## Patient Case Studies

### 1. Large Rotator Cuff Repair with Bioinductive Implant

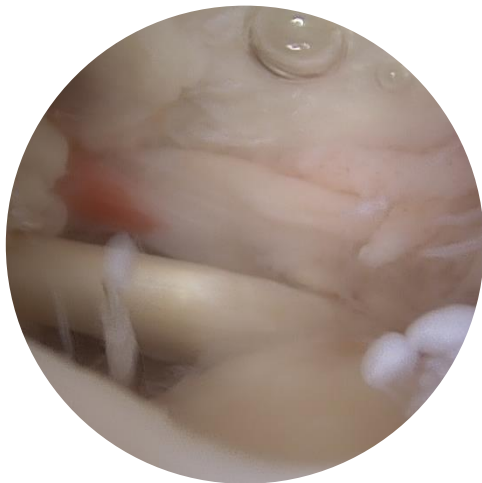
*Figure 1: top view showing large defect in rotator cuff. Notice top of the humerus and biceps tendon which normally cannot be visualized with an intact rotator cuff*

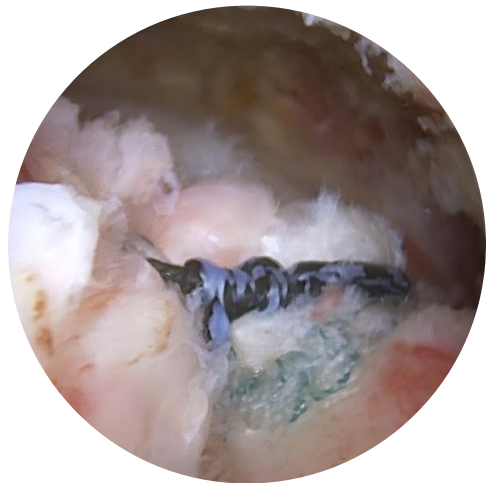
*Figure 2: provisional repair of rotator cuff has been done. Notice the humerus and biceps tendon are no longer visible*

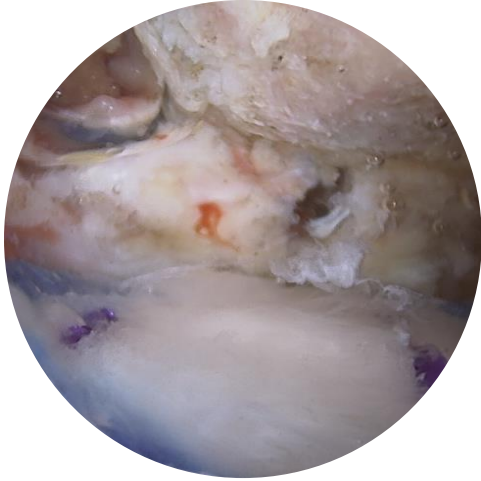
*Figure 3: bioinductive implant (blue and white layer) has been placed on top of the repaired rotator cuff in order to provide additional structural support and strength to rotator cuff*

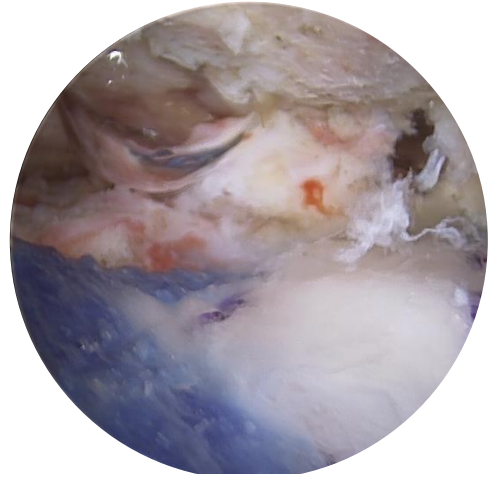
*Figure 4: this additional layer will grow into rotator cuff tissue over 3-6 months*

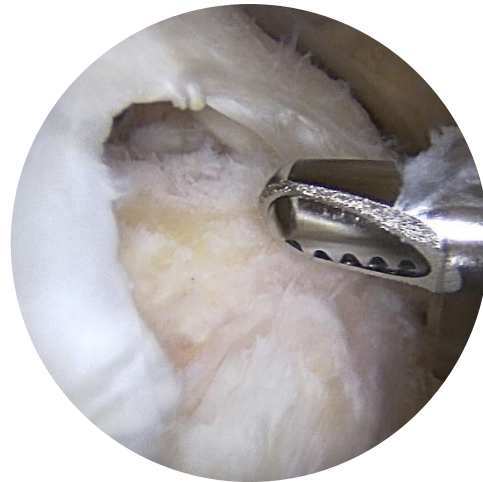
*Figure 6: rotator cuff tissue (left) showing crescent shaped defect to be repaired. A shaver instrument cleans the bone surface prior to repair*

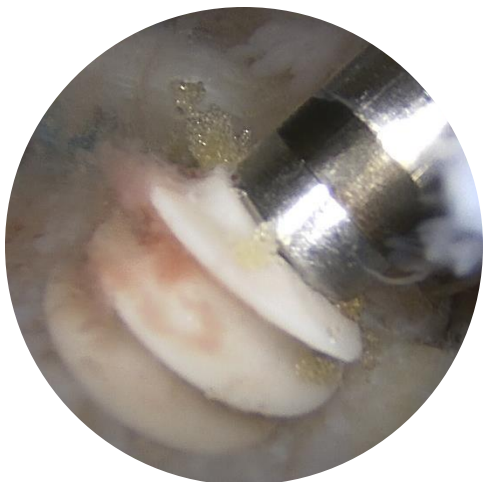
*Figure 7: suture anchor being inserted to attach tendon to bone*

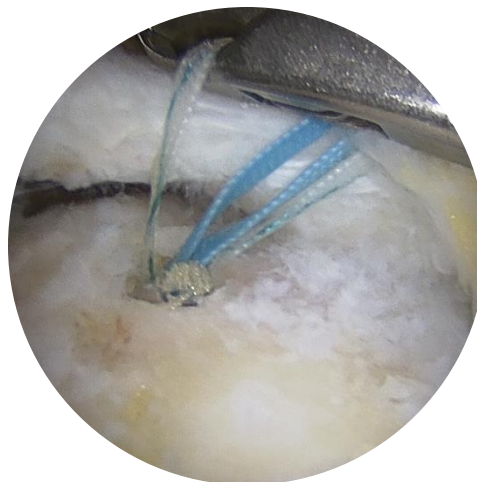
*Figure 8: anchor inserted fully into bone, with visible sutures to be used for tendon repair*

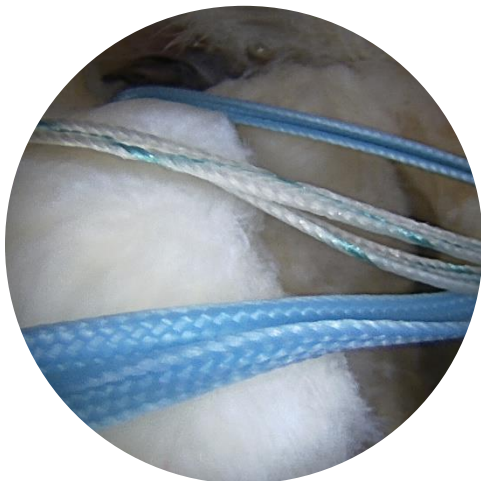
*Figure 9: sutures passed through tendon during repair*

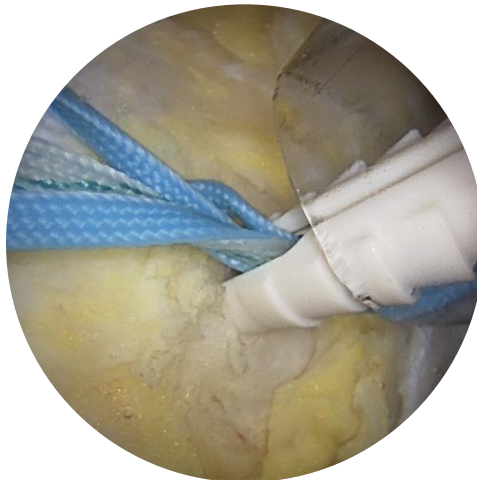
*Figure 10: lateral row anchor being inserted to complete double row repair*

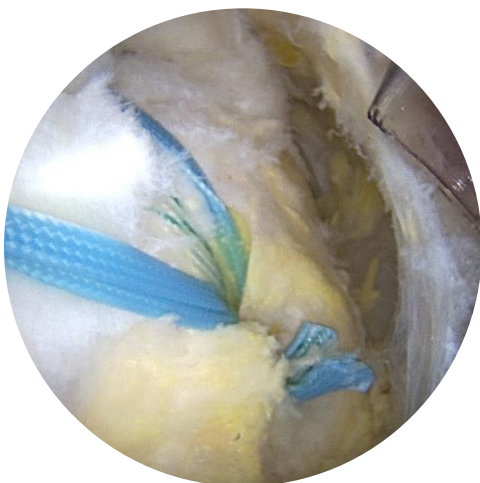
*Figure 11: completed repair, notice crescent defect is no longer visible*

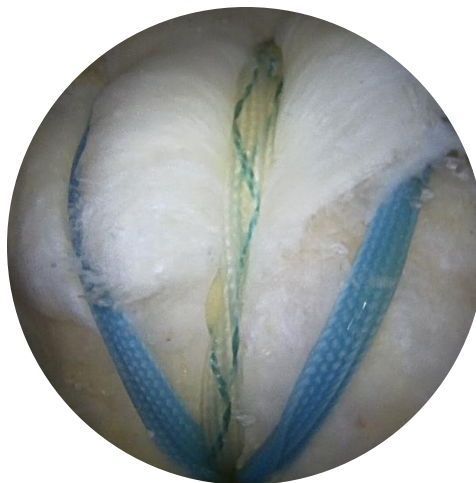
*Figure 12: additional view (front) of repaired tendon. Tendon tissue (upper white) repaired to bone (lower white)*

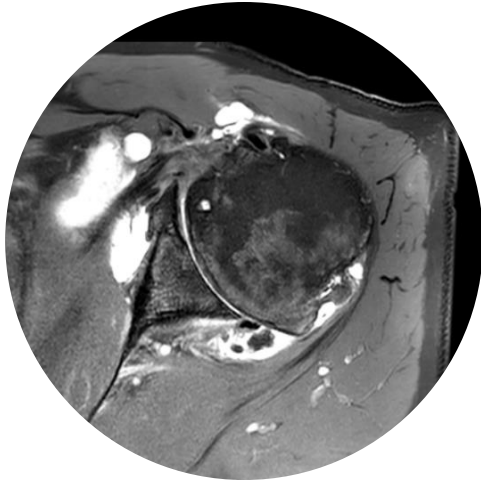
*Figure 13: preoperative MRI of the shoulder from an axial (birds-eye) view showing loss of joint space indicating cartilage loss from arthritis*

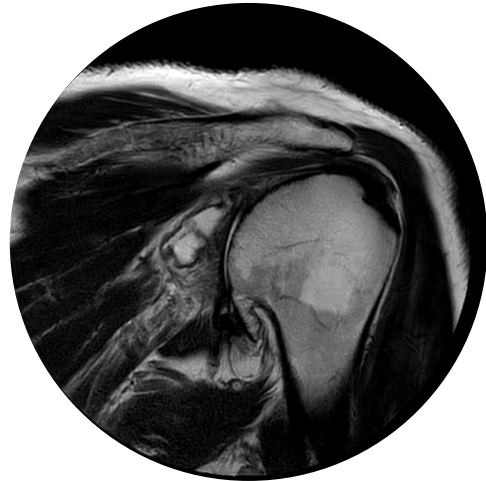
*Figure 14: preoperative MRI of the shoulder from a coronal (front) view showing loss of joint space indicating arthritis*

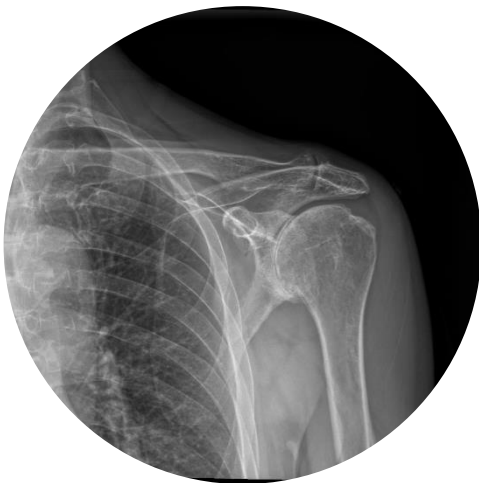
*Figure 15: preoperative x-ray of the shoulder showing narrowing of the glenohumeral joint space, indicative of arthritis*

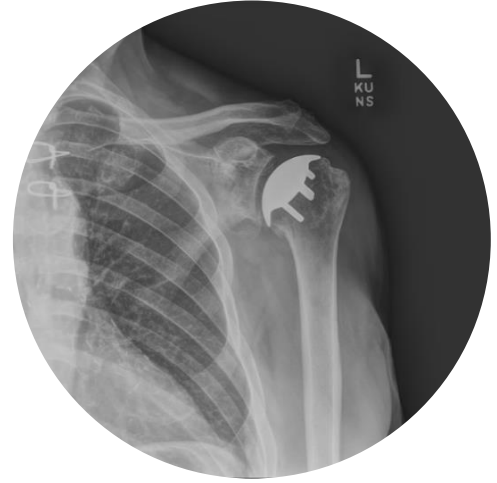
*Figure 16: postoperative x-ray of the shoulder showing positioning of the shoulder replacement implants*

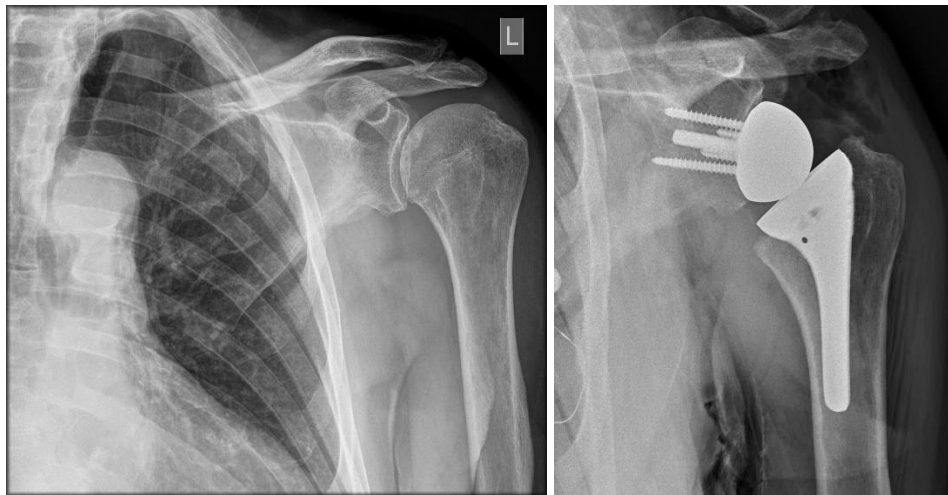
*Figure 17: preoperative x-ray of osteoarthritic shoulder (left) and postoperative x-ray after a reverse total shoulder arthroplasty procedure (right)*
